## *Activities and Interventions of the Coastal Municipalities Water Utility during the war on Gaza 2023-2026*

*May, 2026*

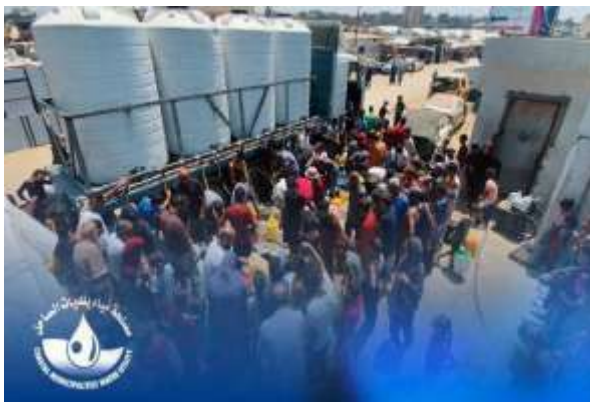
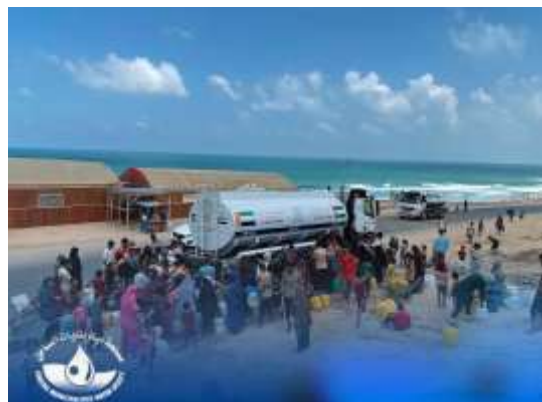
The CMWU supplies water through its owned water tankers, besides the rented private tankers, which represented a turning point in covering the needs of the population and citizens with desalinated water,

in addition the desalination plant are provided with 23 filling points and recently the CMWU has installed additional 10 filling points all around the desalination plant to facilitate filling the water.

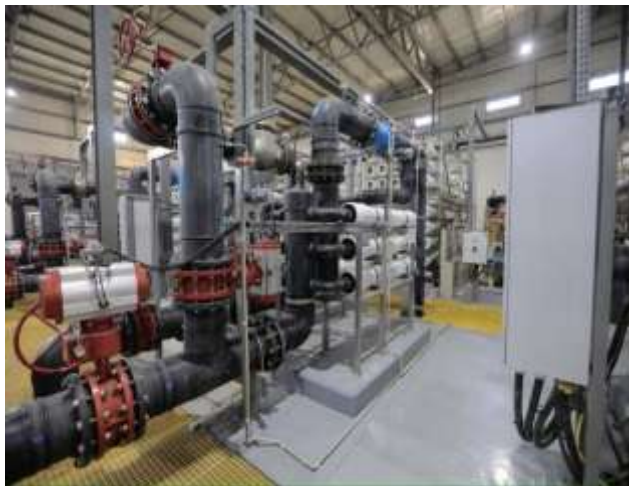
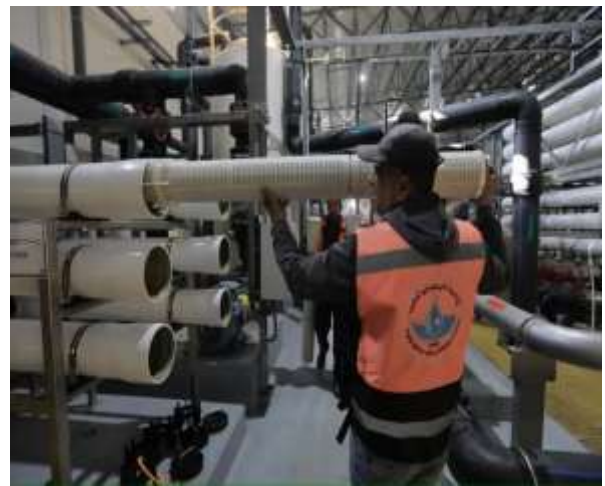
Since 17<sup>th</sup> November 2024, the CMWU started operating SGDP depending completely on the newly connected power line instead of electrical generators which increased the daily production of the plant from 2000 m<sup>3</sup>/day to approximately 17000 m<sup>3</sup>/day. Connecting the plant with the dedicated power line 5 MW was a result of great efforts exerted by the CMWU and PWA in order to operate the plant with its full capacity to cover part of the high-water demand during the current situation. However, the power line frequently suffers damage, leading to some drop in water production. In May, the average daily water production was **14,952m<sup>3</sup>/day**.

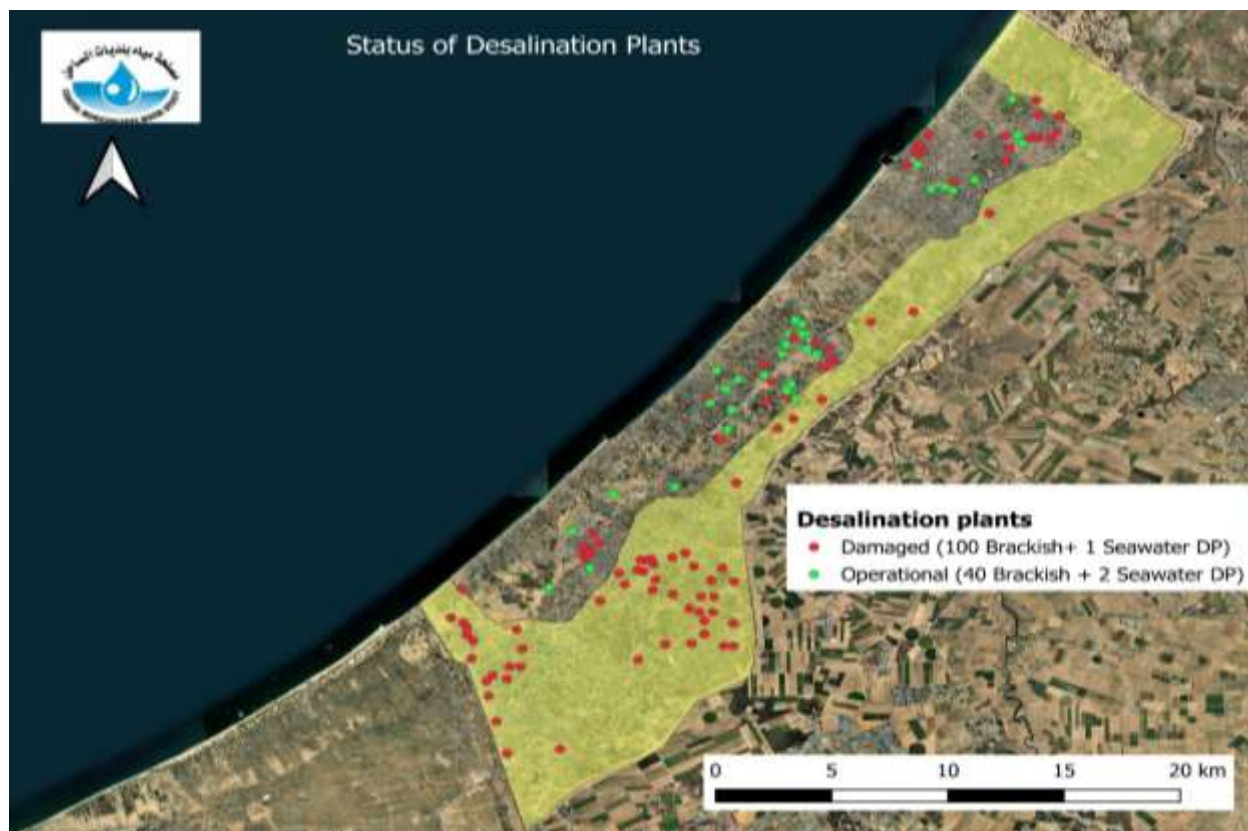
Status of Desalination plants

During the war most of brackish desalination plants have been damaged, whereas the current operational plants are 40, most of which are located in the Middle Area, as illustrated *in the map below*, since this area experienced less destruction compared to other parts of the Gaza Strip. The production capacity of these plants ranges from 7 to 760 m<sup>3</sup>/day.

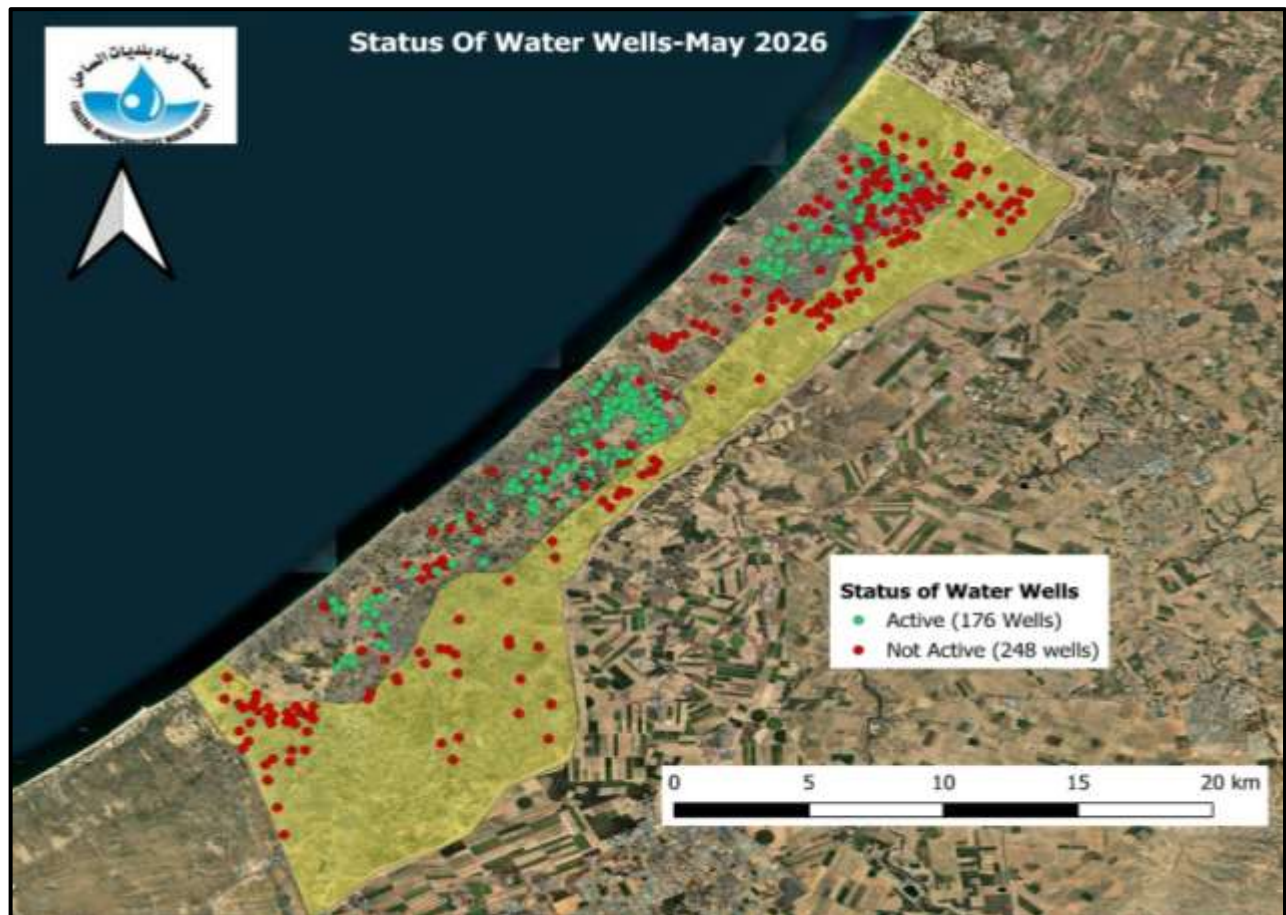
Operational Water Wells- May 2026

Limited water wells are still operational during war as most water wells are partially or completely damaged, hence the daily domestic water production from wells over war months did not exceed 25% of the original production. The below figures show the records of monthly water production from February 2024 till May 2026, whereas the fluctuation in water production depends on fuel availability, security issues and status of facility (operational or damaged) during each month. In May 2026, water production increased as additional wells are brought back into operation particularly in Gaza and North Gaza. The CMWU is continuing its efforts to repair more facilities and provide electrical generators to re-operate accessible vital wells. The average daily water production from municipal and secondary **operational wells** during May reached **83,951 m<sup>3</sup>** during the month, reflecting the impact of recent rehabilitation and repair works. The map below illustrates the operational status of municipal wells across the Gaza Strip.

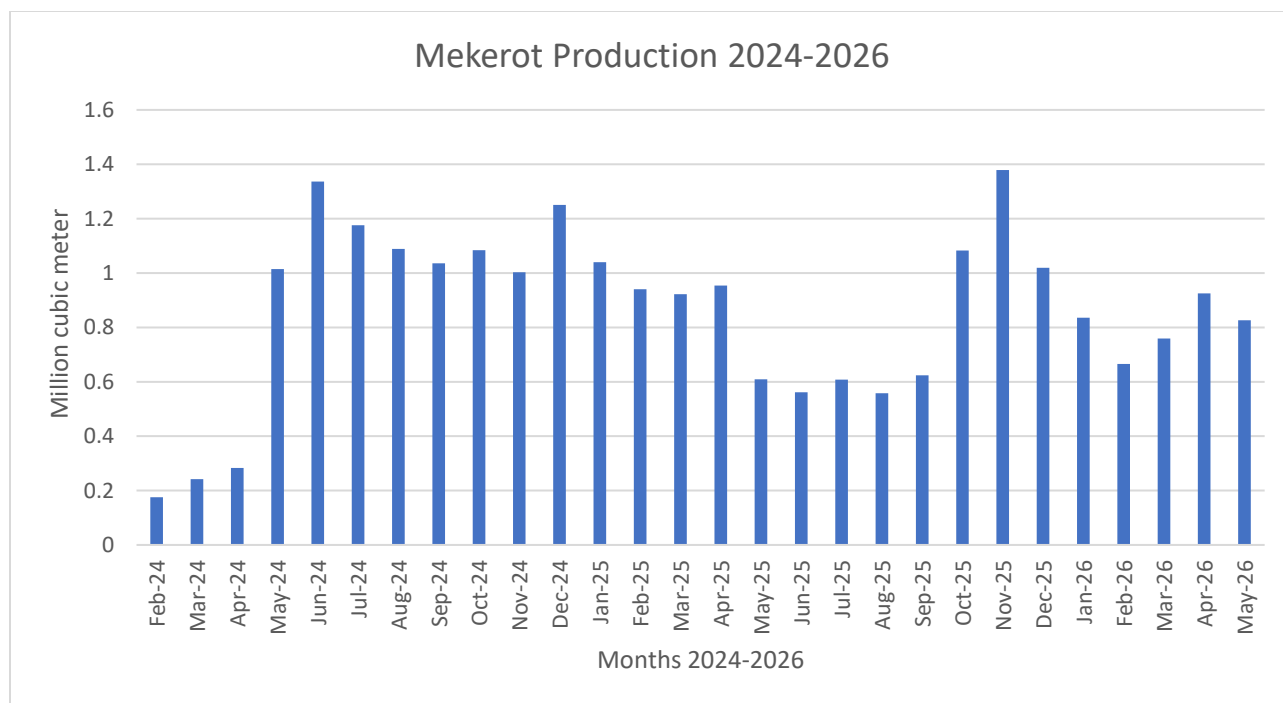
Mekorot monthly production from February till May 2026

- The first in the middle governorate called Ben Saed with a capacity 14,000 m<sup>3</sup> /day, this source has been non-operational for nearly ten months due to severe damage to the feeding pipeline. The pipeline has been in operation since October 2025. However, in May 2026, it experienced a severe reduction in water supply, with more than 85% of its normal capacity lost. As a result, the average daily water production from this connection dropped to approximately **2,328 m<sup>3</sup>/day** during May 2026.
- The second is east Khan Younis connection with a capacity of 16,000 m<sup>3</sup>/day, where it is working during the month with average daily of **12,455 m<sup>3</sup>**.
- The third for Gaza governorate with 20,000 m<sup>3</sup>/day capacity, where it is working during the month with average daily of **12,257 m<sup>3</sup>**.

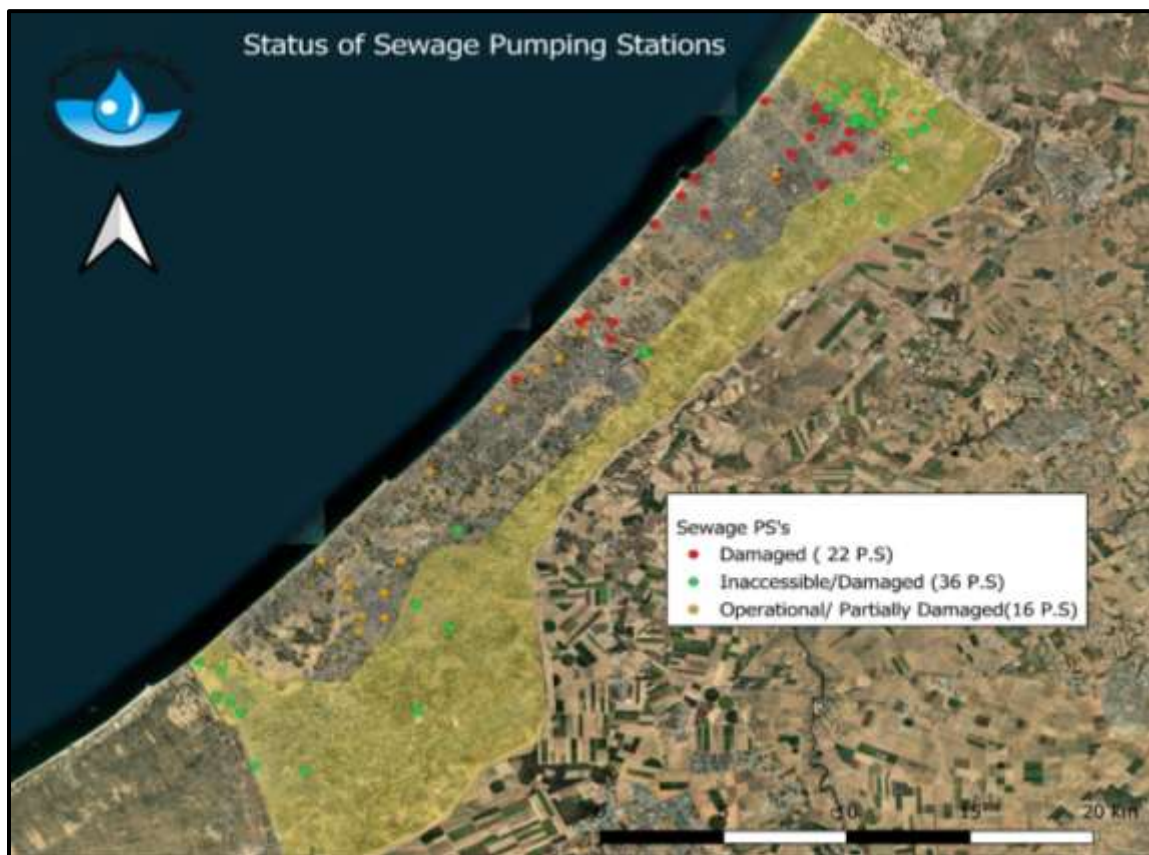
Status of Sewage PS till May 2026

The operational and accessible sewage pumping stations till May 2026 remains 16 whereas *The map indicates* that most pumping stations are located in inaccessible areas and are likely damaged.

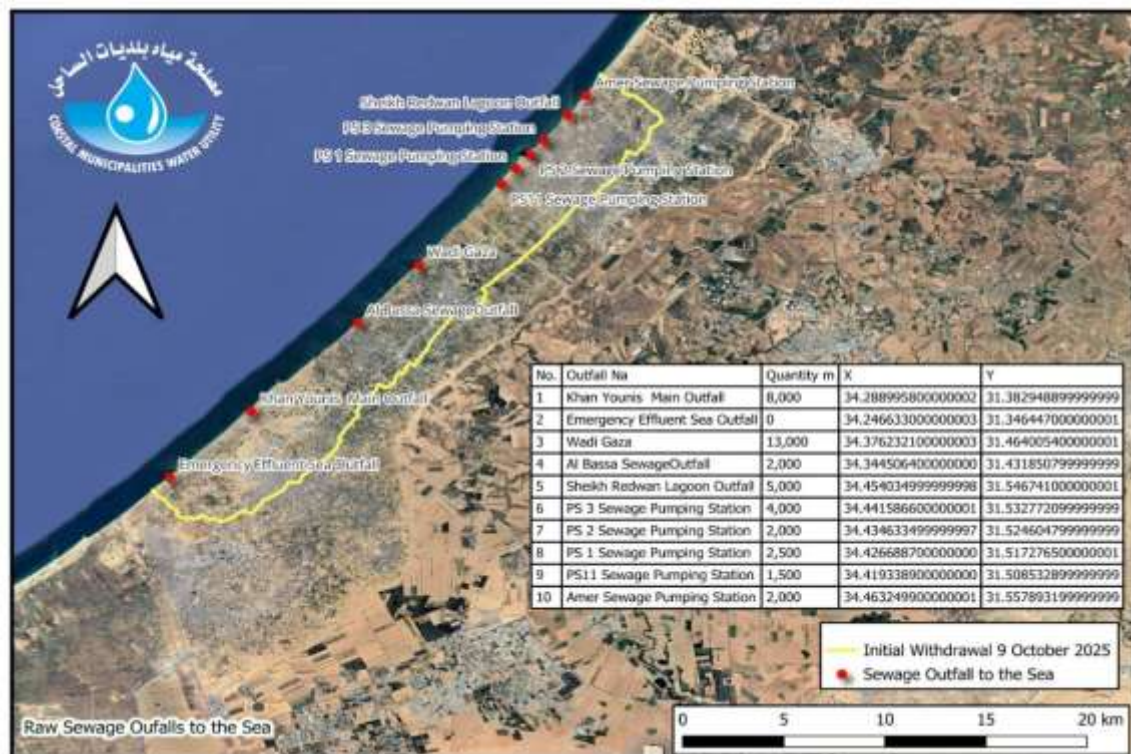
Sewage Outfalls to the sea

The daily discharge of raw sewage to the sea through the ten indicated outfalls is approximately **40,000 m<sup>3</sup>** which resulted in environmental and health hazards along the coastal side.

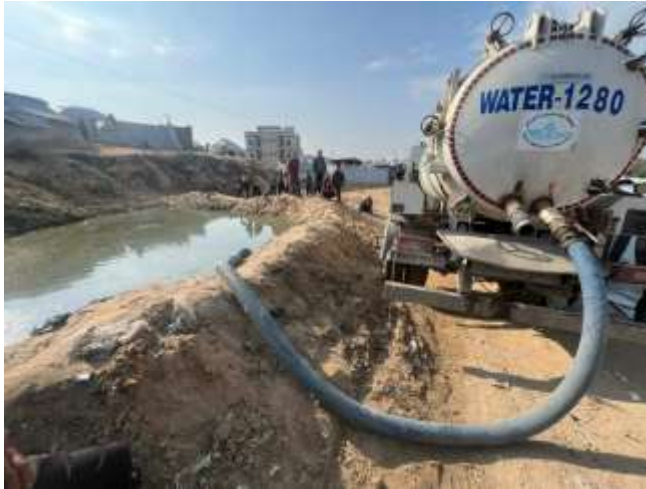
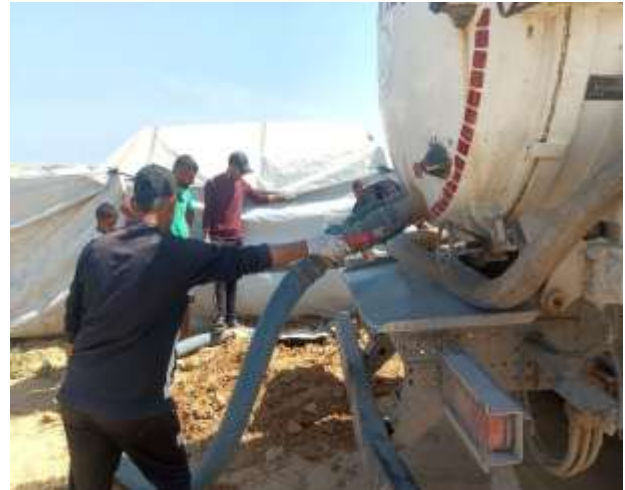
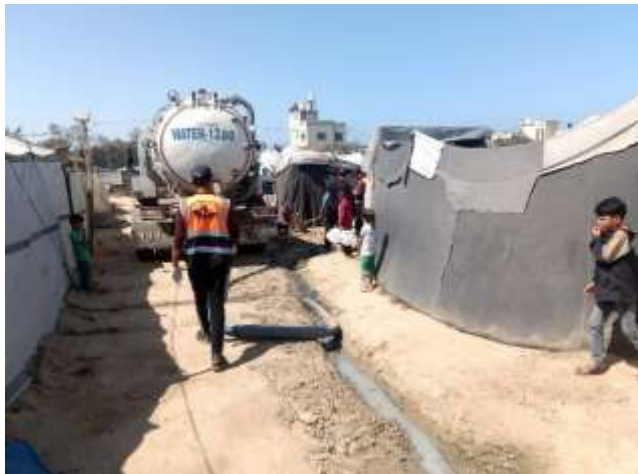
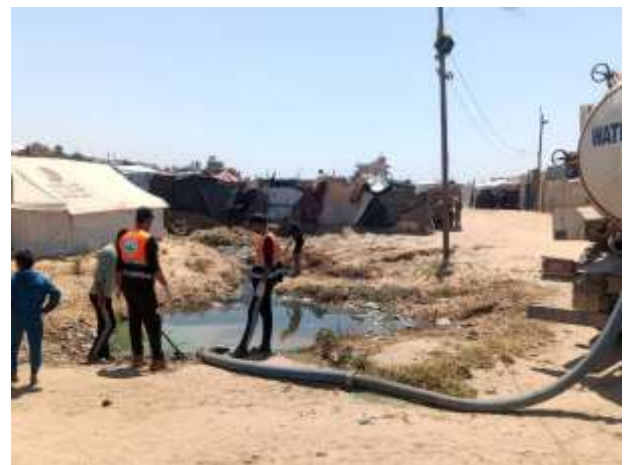
**In May 2026**, the CMWU teams carried out emergency interventions to address the impacts of sewage floods particularly in IDPs sites through utilization its sewage suction truck to evacuate the sewage from many random ponds in different IDPs sites in Dair AL Balah, Al Nussirat, Al Burej, AL zawayida, Mawasi Khan Younis, which hosting thousands of IDPs

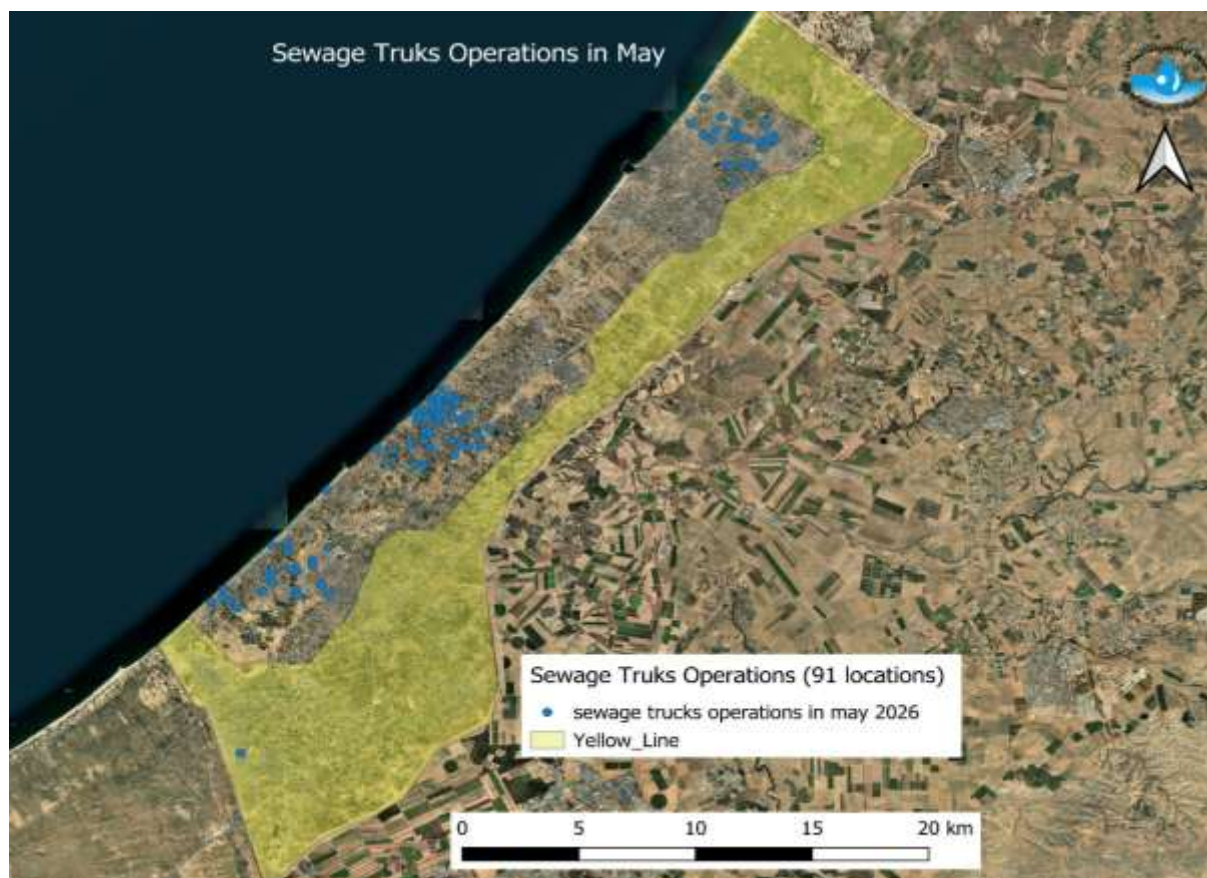
In addition to the above operations, the CMWU also deployed the sewage jetting and suction trucks available in its warehouse in Khan Younis to respond to emergency requests and appeals in north Gaza and Southern governorates. In May 2026 the two trucks conducted approximately 91 intervention operations. The spatial distribution of these interventions is illustrated in the map below.

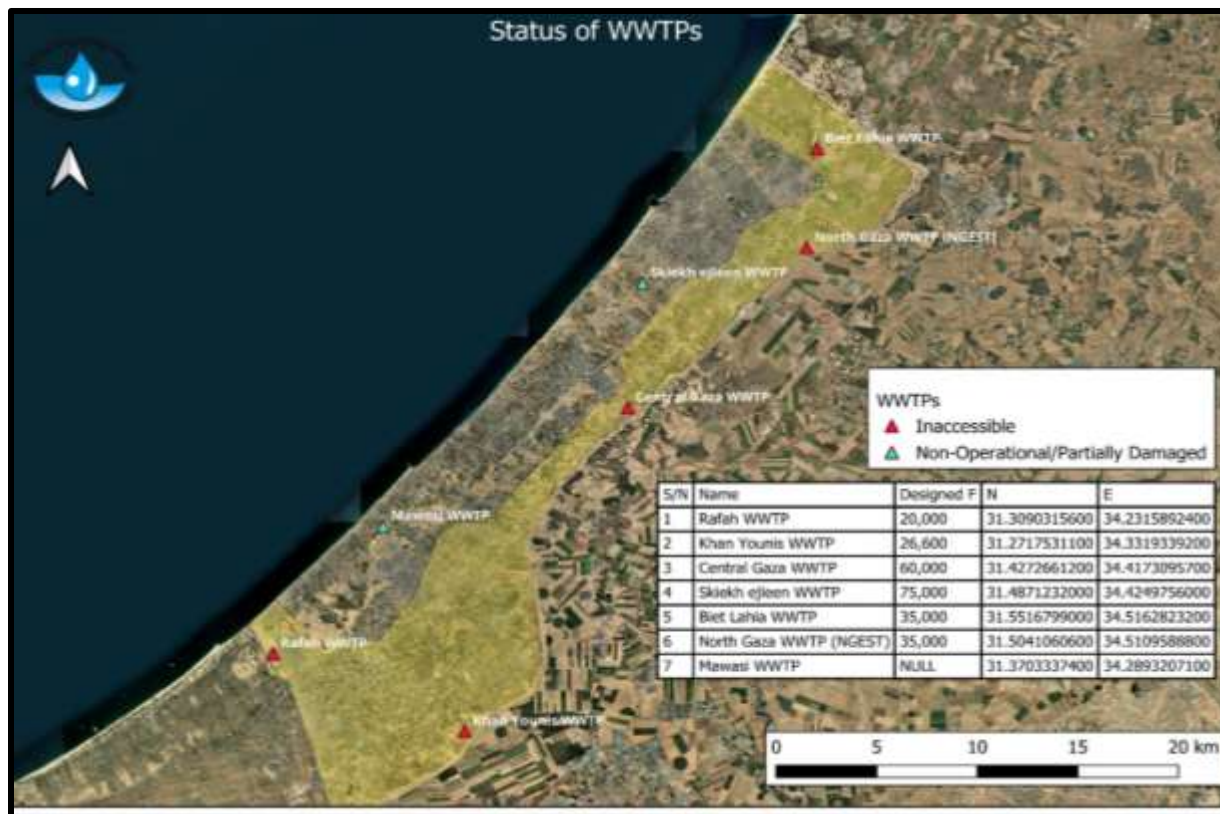
During the war the operation of the three central plants (KHHWTP, BWWTP and NWWTP) stopped due to the severe destruction in their main structures. Also, the operation staff could not reach these plants as they are located in the yellow area *as shown in the below map*. As a result of this stoppage, currently most of the generated sewage is diverted to the sea without treatment causing pollution along the coastal side.

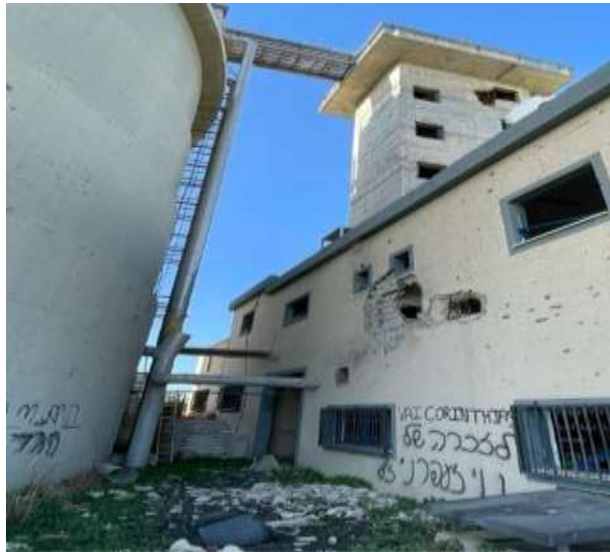
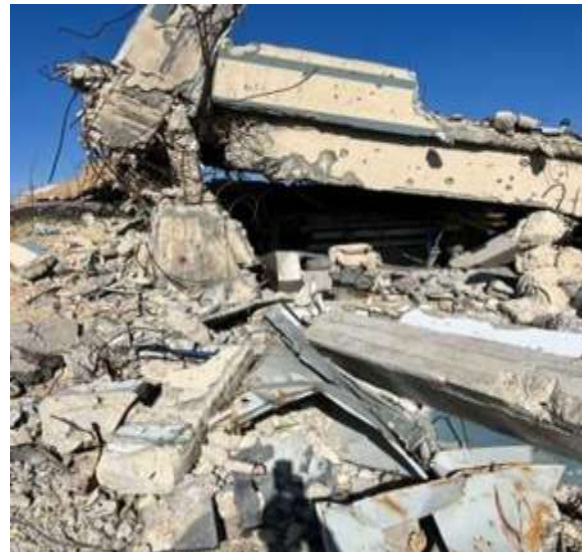
In June 2024, CMWU and PWA coordinated for an inspection visit to Gaza Central Wastewater Treatment Plant (GCWWTP). The visual inspection revealed that several plant's components and structures had sustained severe damage.

Approximately two years later, UNICEF, supported by a KFW has requested a coordinated site visit. On 11 February 2026, approval was issued by CLA for UNICEF staff to access the site. The team conducted a visual inspection, which confirmed that multiple structures and components were damaged. However, due to limited time and the extent of destruction, the team was unable to inspect some underground infrastructure, as well as certain rooms on upper floors and rooftops.

The findings from both inspections should be further analyzed by a team of wastewater treatment experts to support the preparation of a comprehensive technical assessment. A detailed assessment mission, involving a multidisciplinary team, is recommended and would require approximately 2 to 4 weeks on site. This mission should be supported by manual laborers and excavation equipment to enable access to facilities and underground networks currently obstructed by rubbles.

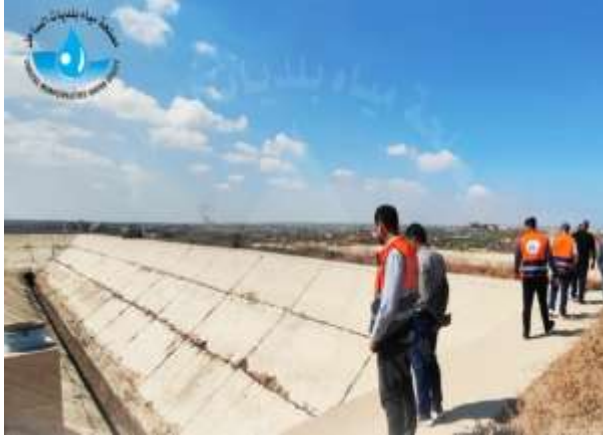
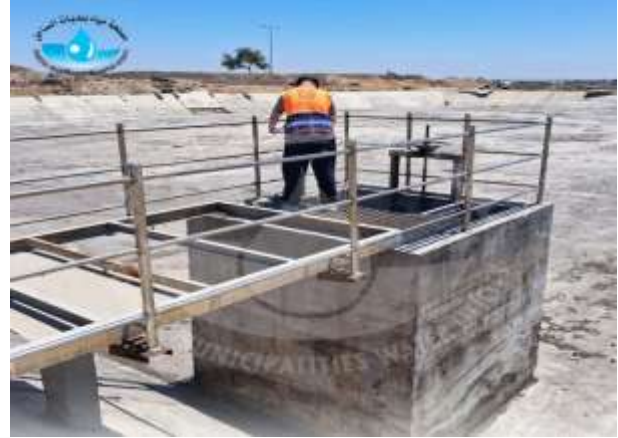
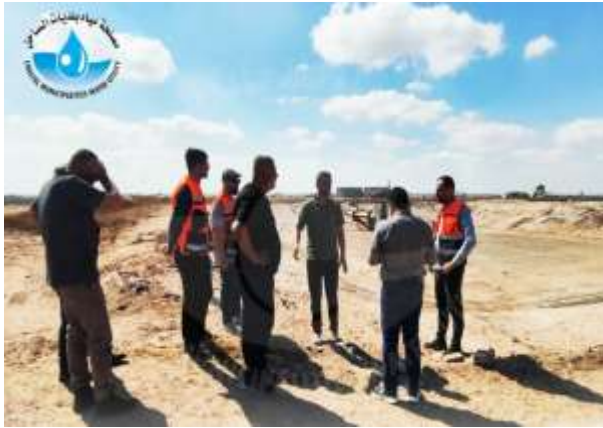
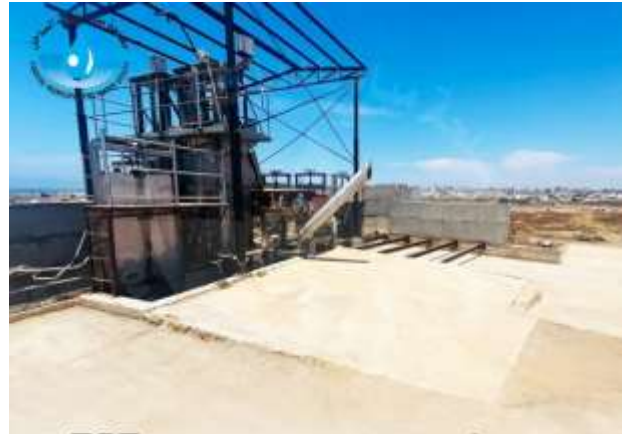
In addition, localized maintenance works were completed on the concrete basins, including the repair of cracks and various damages resulting from previous operation and cleaning activities. The control gates were also serviced, loosened, and lubricated to ensure their operational readiness and ease of use when the plant resumes operation.

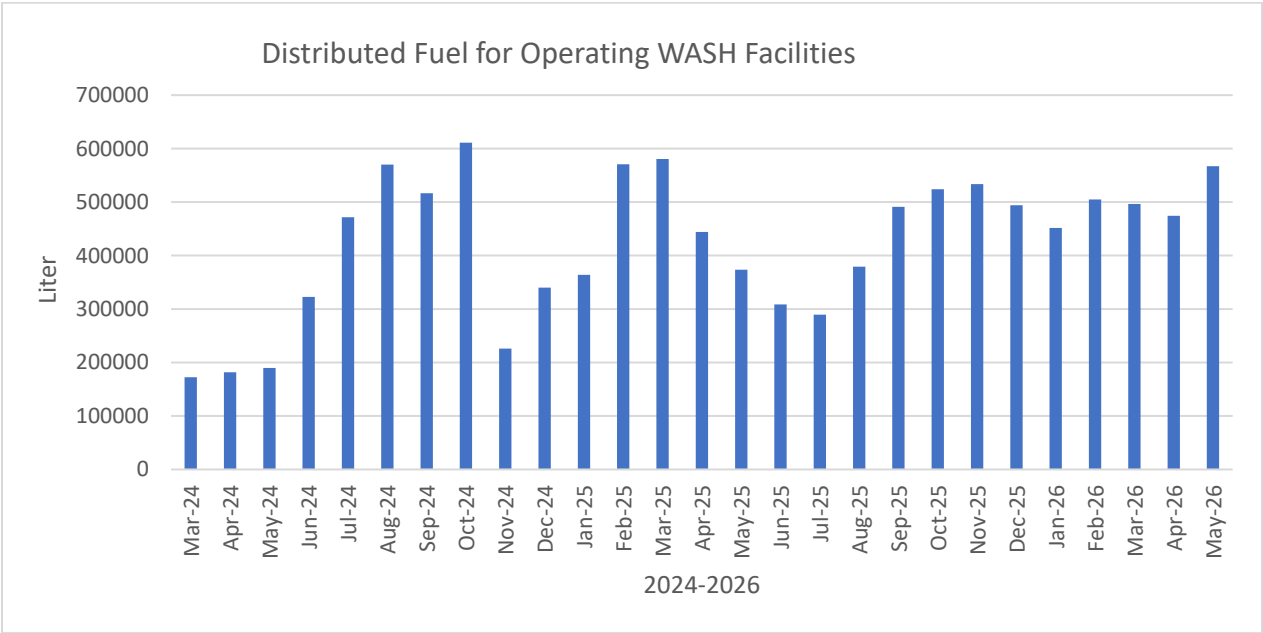
Distributed fuel for operation WASH facilities

The figure below illustrates fuel distribution to WASH facilities in the middle and southern governorates from March 2024 to May 2026. Fuel distribution remained relatively stable during the past months. However, the main challenge affecting the operation of WASH facilities is the shortage of lubricant oils, as the Israeli authorities continue to restrict their entry. This threatens the operation of generators, most of which have exceeded the allowable operating hours and require oil replacement *as indicated in the below map*.

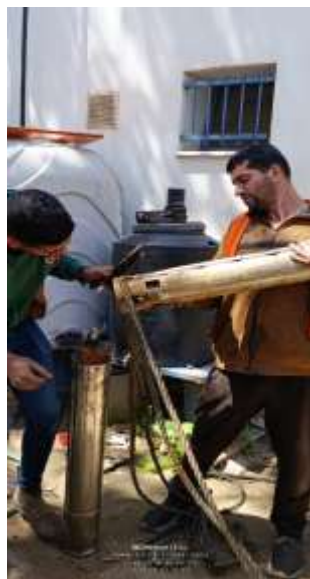
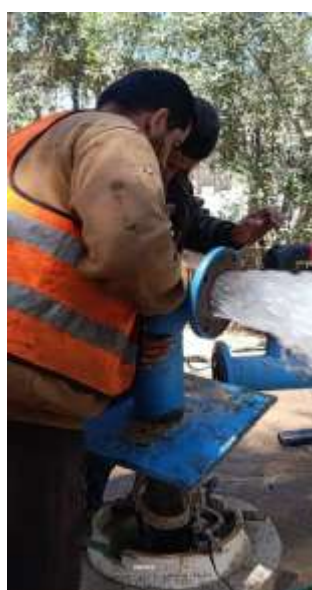
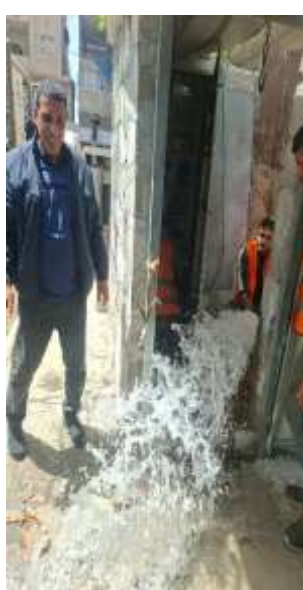
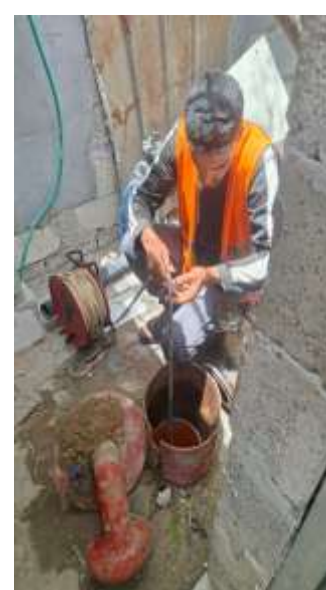
| Item | Facility | Municipality | Description | Lat. | Long. |
|---|---|---|---|---|---|
| 3 | Najjar - Kartia well | Nusairat | Maintenance work of submersible pump 20 HP. | 34.389800 | 31.447620 |
| 4 | Basmet Amal Camp's well | Rafah | Rewinding of submersible pump 5.5 HP, and the work includes:<br>- installation the pump after performing the necessary maintenance. | 34.288724 | 31.375085 |

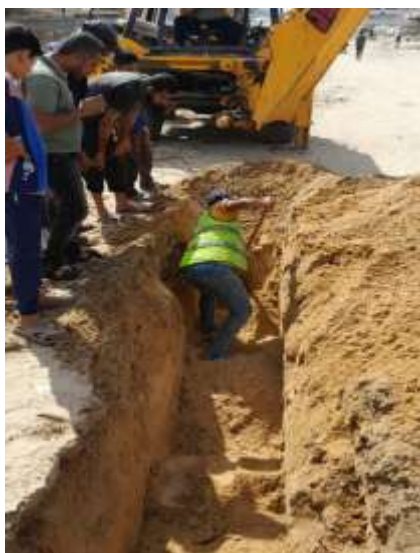
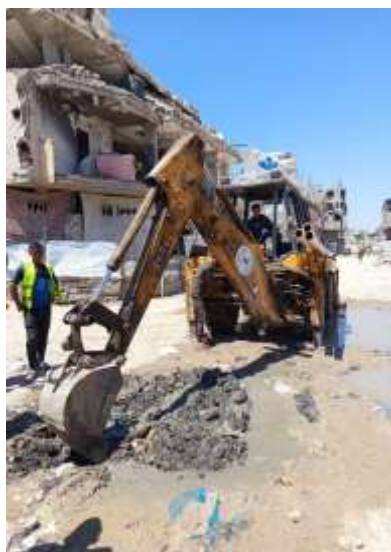
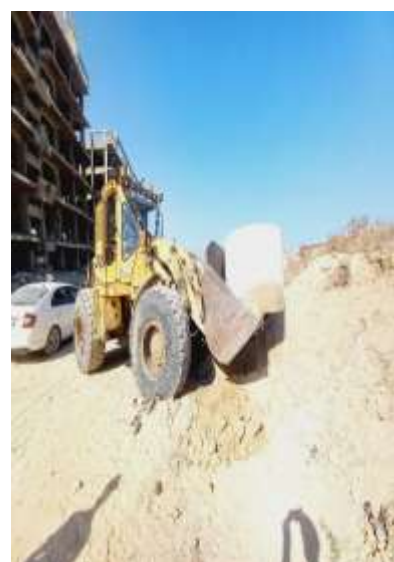
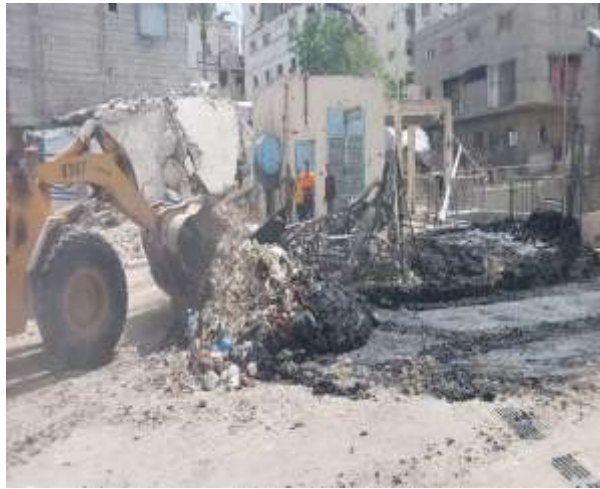
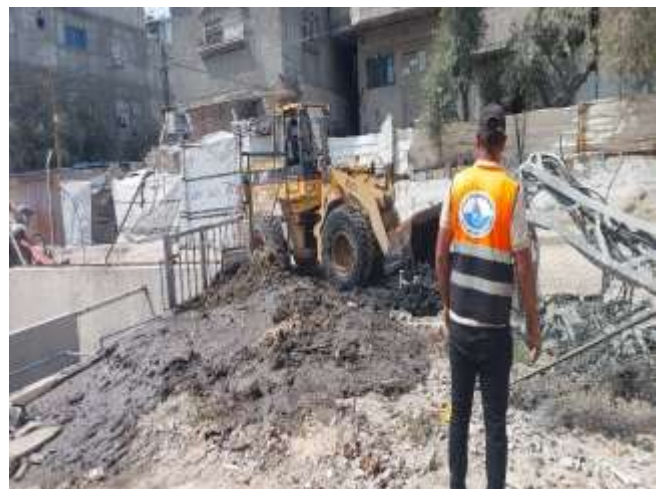
| Municipality | Description |
|---|---|
| Dair Al-Balah | The works included: <ul style="list-style-type: none"><li>- Install water and wastewater pipe different diameters.</li><li>- cleaning and maintenance of sewage pipelines</li><li>- Maintenance works of water pipe different diameters &amp; gate valve.</li><li>- Remove all waste concrete elements on water line &amp; Open Roads.</li></ul> |
| Gaza and Jabalia | The works included: <ul style="list-style-type: none"><li>- Install water and wastewater pipe with different diameters.</li><li>- Maintenance of water and wastewater pipes with different diameters.</li><li>- Cleaning works for sewage lines and Manholes &amp; pumping stations.</li><li>- assessment and inspection the damages of sewage manholes.</li><li>- Remove all waste concrete elements of wastewater lines</li></ul> |

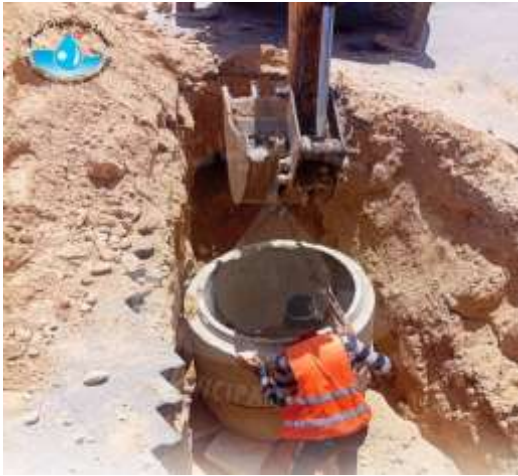
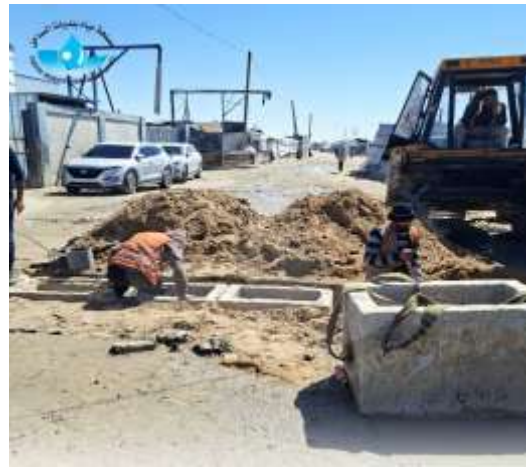
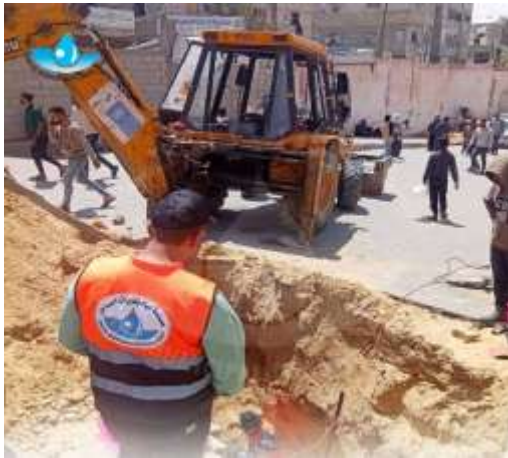
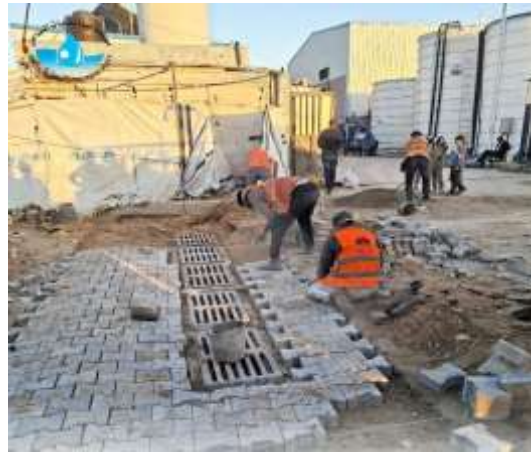
The interventions also included the installation of stormwater drainage gullies in front of CMWU's main warehouses to reduce water accumulation resulting from filling points associated with the desalination plant, which had been causing public health and environmental nuisances.

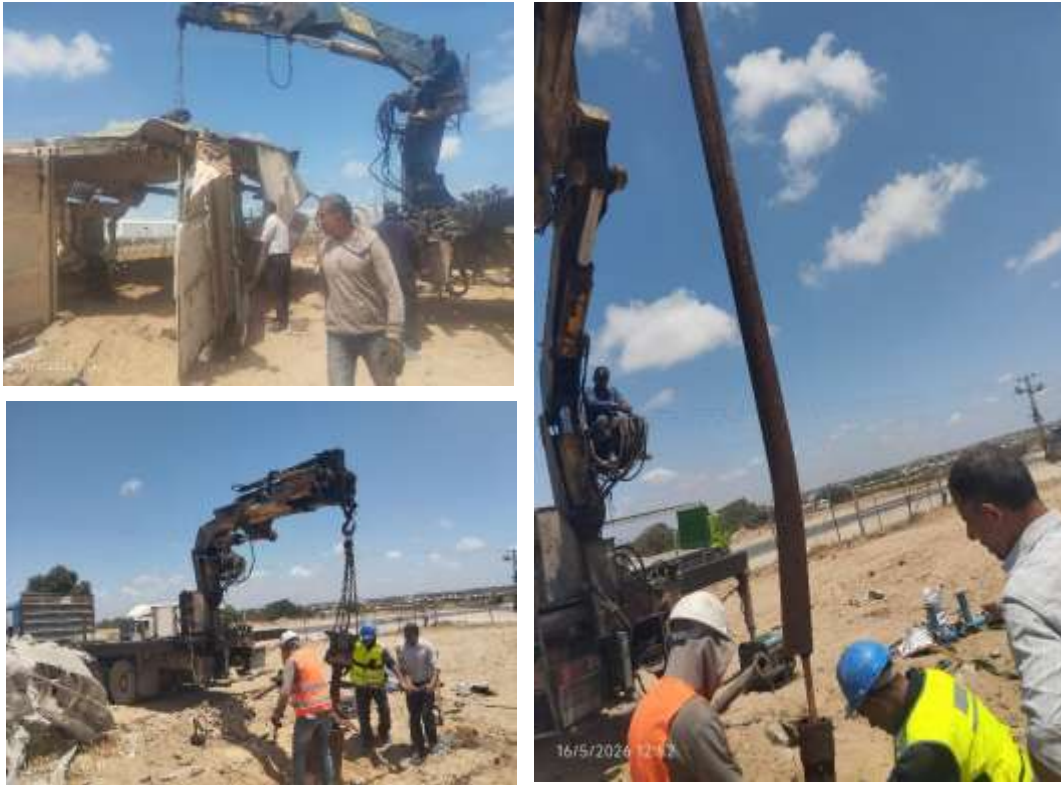
- Dismantle of existing destroyed steel container and transferred it to Al Qarara municipality store.
- electromechanical works for well's component through replacement all damaged and non-functional equipment

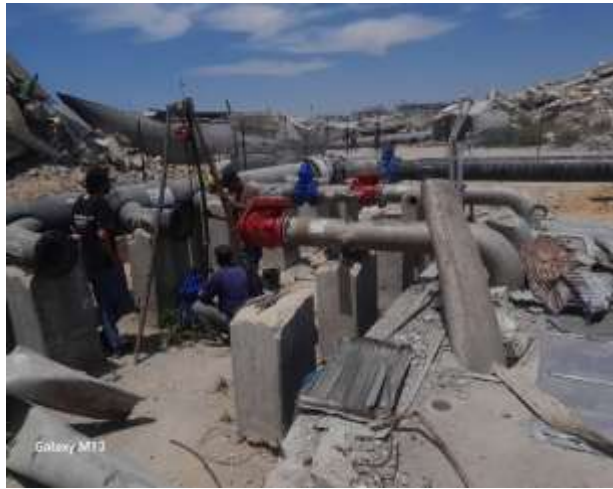
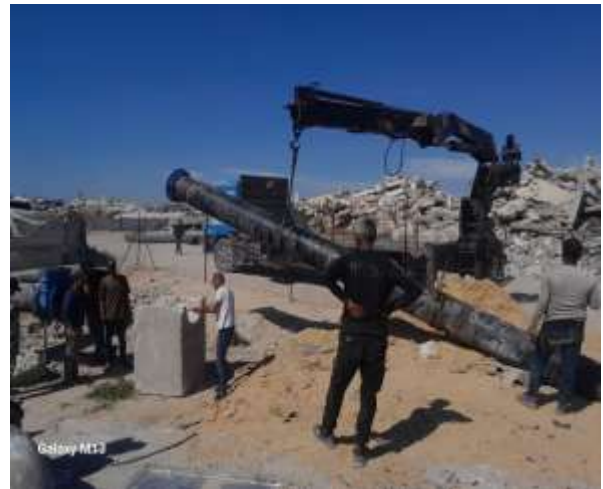
This project forms part of CMWU's ongoing efforts to address urgent humanitarian needs and reduce the environmental and public health risks associated with sewage flooding, through the rehabilitation of key pumping stations and transmission pipelines to enable the safe transfer of wastewater and prevent flooding in residential areas.

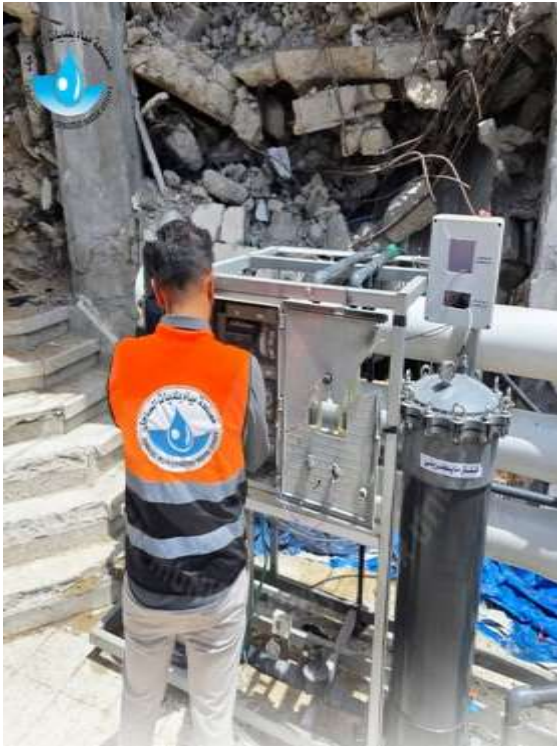
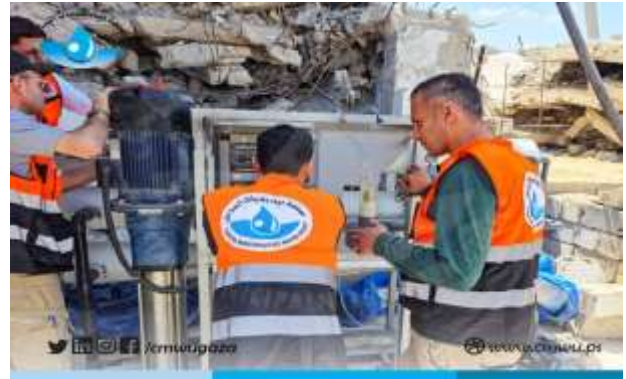
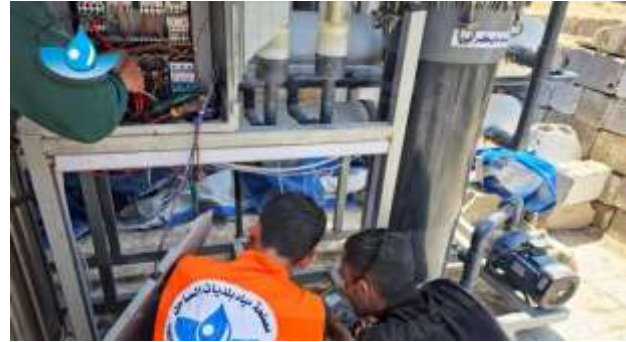
The technical teams of the CMWU carried out maintenance, installation, and commissioning works for "Qarmout" Water Desalination Plant in Jabalia, which has a production capacity of 8 cubic meters per hour. The intervention aims to serve residents and displaced people in Jabalia, particularly with the onset of the summer season and the increasing demand for safe drinking water amid the scarcity of water resources and the challenging conditions currently facing the Gaza Strip.

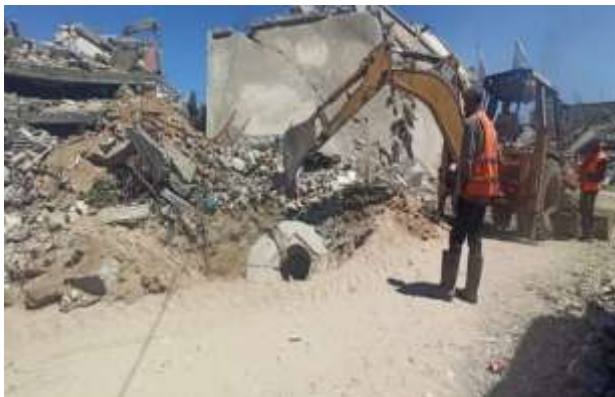
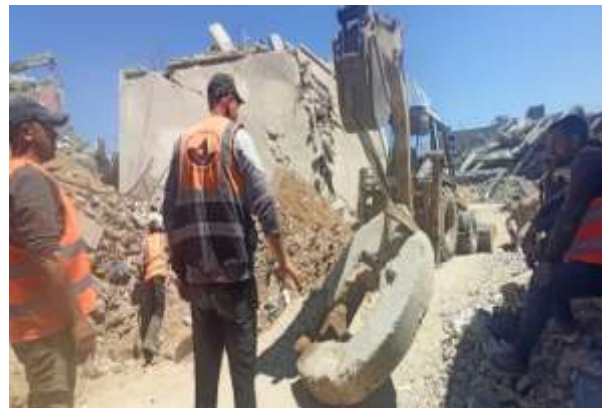
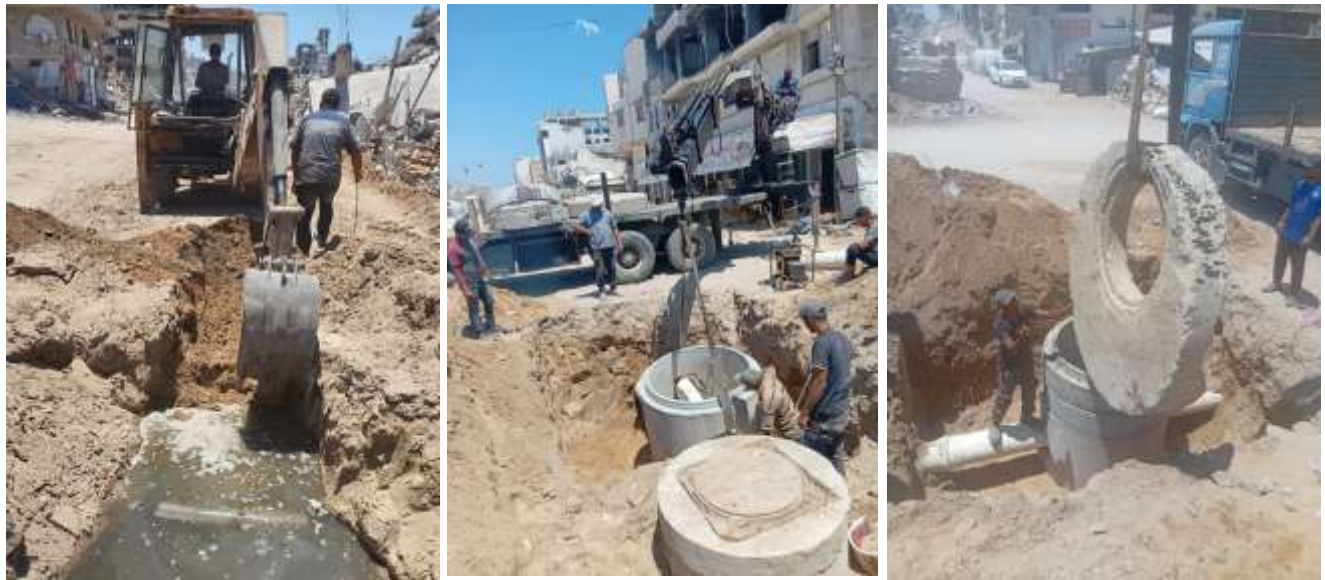
The CMWU through UNICEF support and under hiring machineries and labors contract has carried out many of emergency maintenance works for water and wastewater networks and facilities in the areas of Jabalia, Beit Lahia, Gaza City, the Middle Governorate, and Khan Younis. The works including cleaning and maintenance of sewage manholes, dismantling pipes, replacement the damages parts of pipelines and many repairs that ensure continuity of water and wastewater essential services.

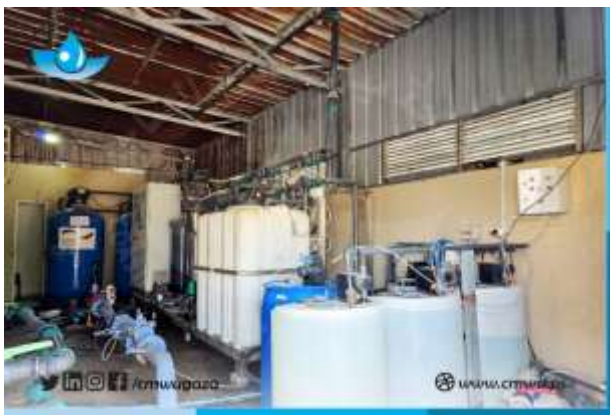
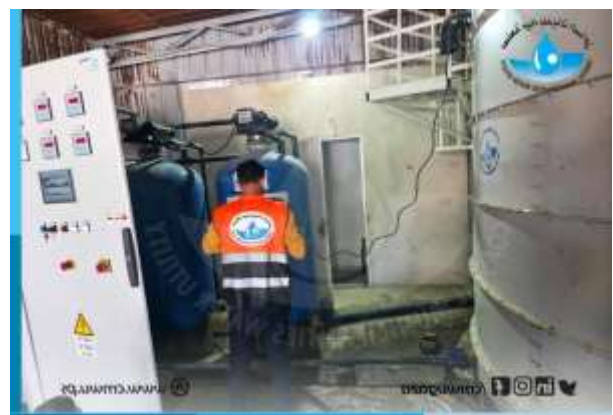
The technical teams of the CMWU as part of their ongoing efforts to ensure the continuity of water services across the Gaza Strip, carried out emergency maintenance works at Al Rawda Well Desalination Plant in the Al-Zawaida area. The plant has an operational capacity of 12 cubic meters per hour. These interventions were undertaken to prevent service interruptions and ensure the continued provision of water to residents, particularly under the current circumstances, with the onset of the summer season and the increasing demand for safe drinking water.

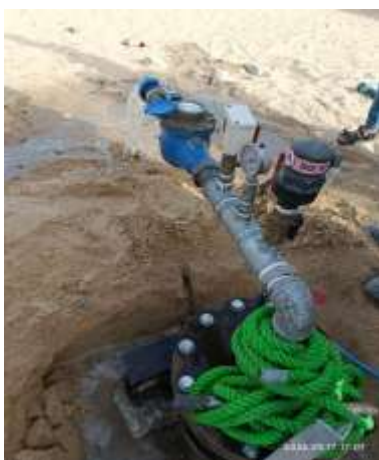
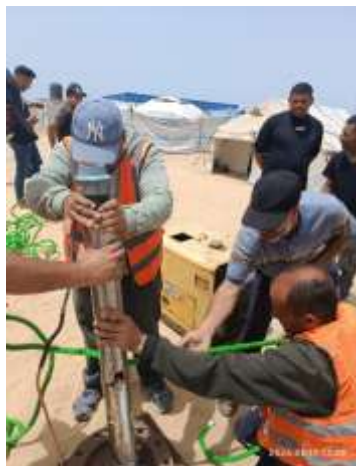
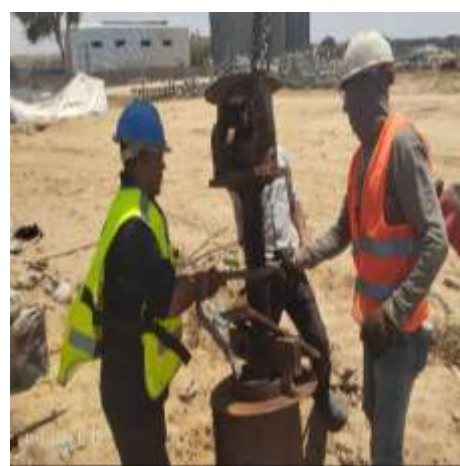
The CMWU through UNICEF support has completed the construction of four out of five water wells. Two of these are municipal wells with a production capacity of 60 m<sup>3</sup>/hr, located in Al-Zaytoon area in Gaza City and in the Western Camp area of Khan Younis which is still ongoing.
