## *Activities and Interventions of the Coastal Municipalities Water Utility during the war on Gaza 2023-2026*

*May, 2026*

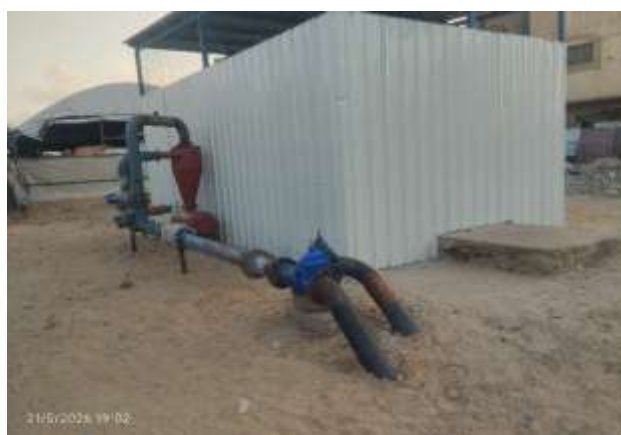
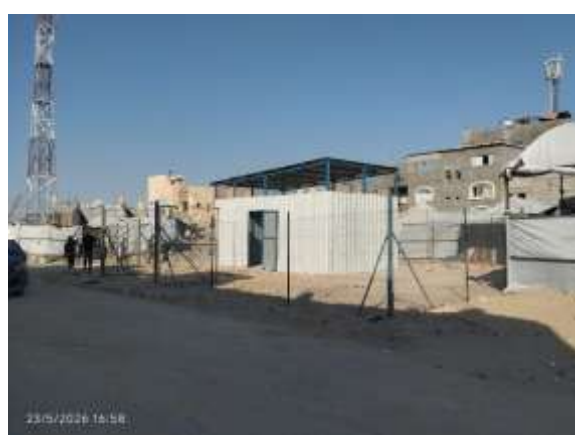
The CMWU through Oxfam fund and in cooperation with PEF has completed the rehabilitation works of “Northern UN well” water well in Khan Younis City, as part of ongoing efforts to improve water services and meet the needs of residents and displaced people in the western areas.

The well serves the western neighborhoods of the city, supplying water to “Al-Buraq” reservoir, which in turn distributes water to several neighborhoods, including the Japanese Neighborhood, Emirati Neighborhood, Dutch Neighborhood, Western Camp, and Al-Amal neighborhood.

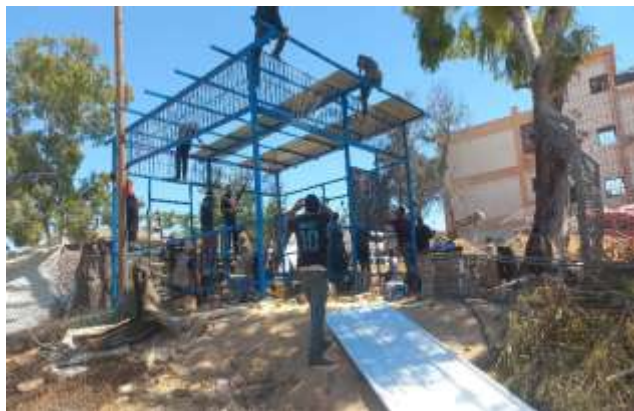
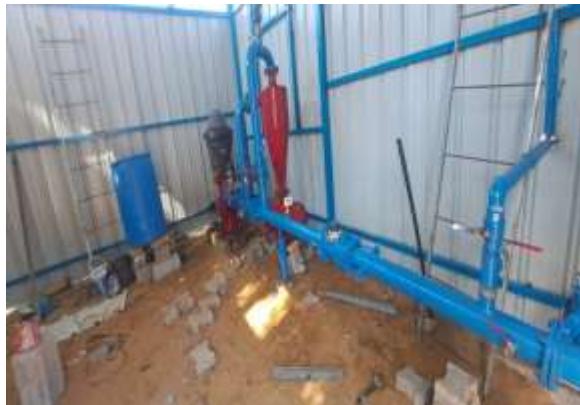
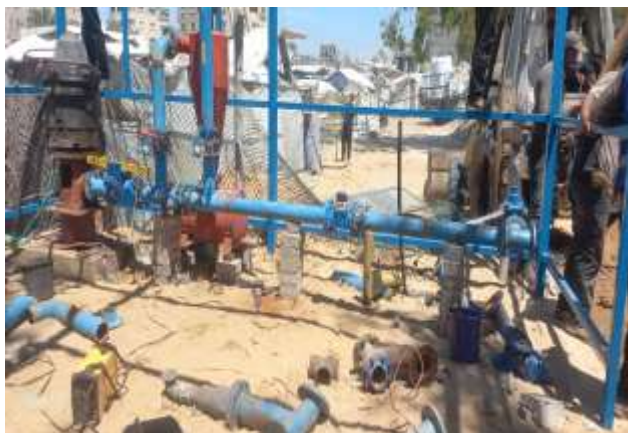
With support from Oxfam and ESDC, CMWU is undertaking the rehabilitation of two water wells in Gaza City. The works include the maintenance and replacement of well pumps, manifolds, main transmission pipelines, and electrical control panels, as well as the construction of steel structures for the well facilities.

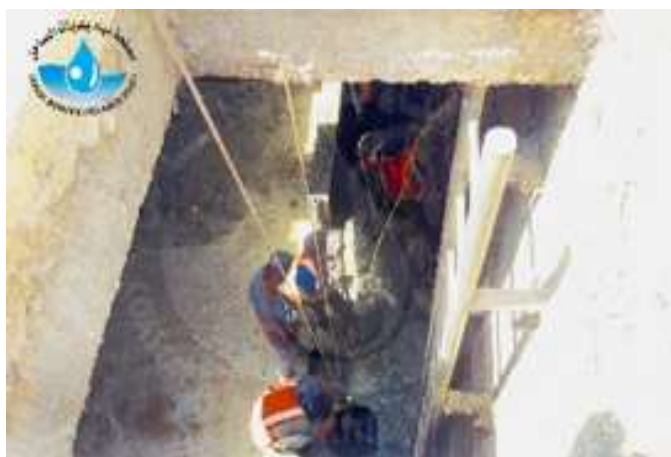
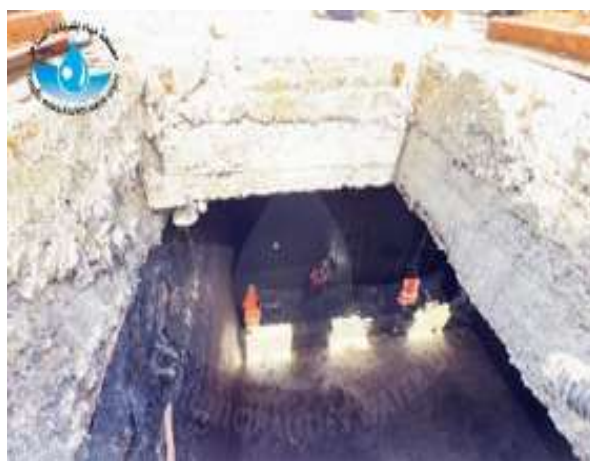
The CMWU through Oxfam support has completed the maintenance and cleaning of 13 sewage pumping stations including 7 sewage PS in Khan Younis, 2 in Dair Al Balah, 1 in Zawiya, 1 in Al Nussirat and 2 stations in Gaza city.

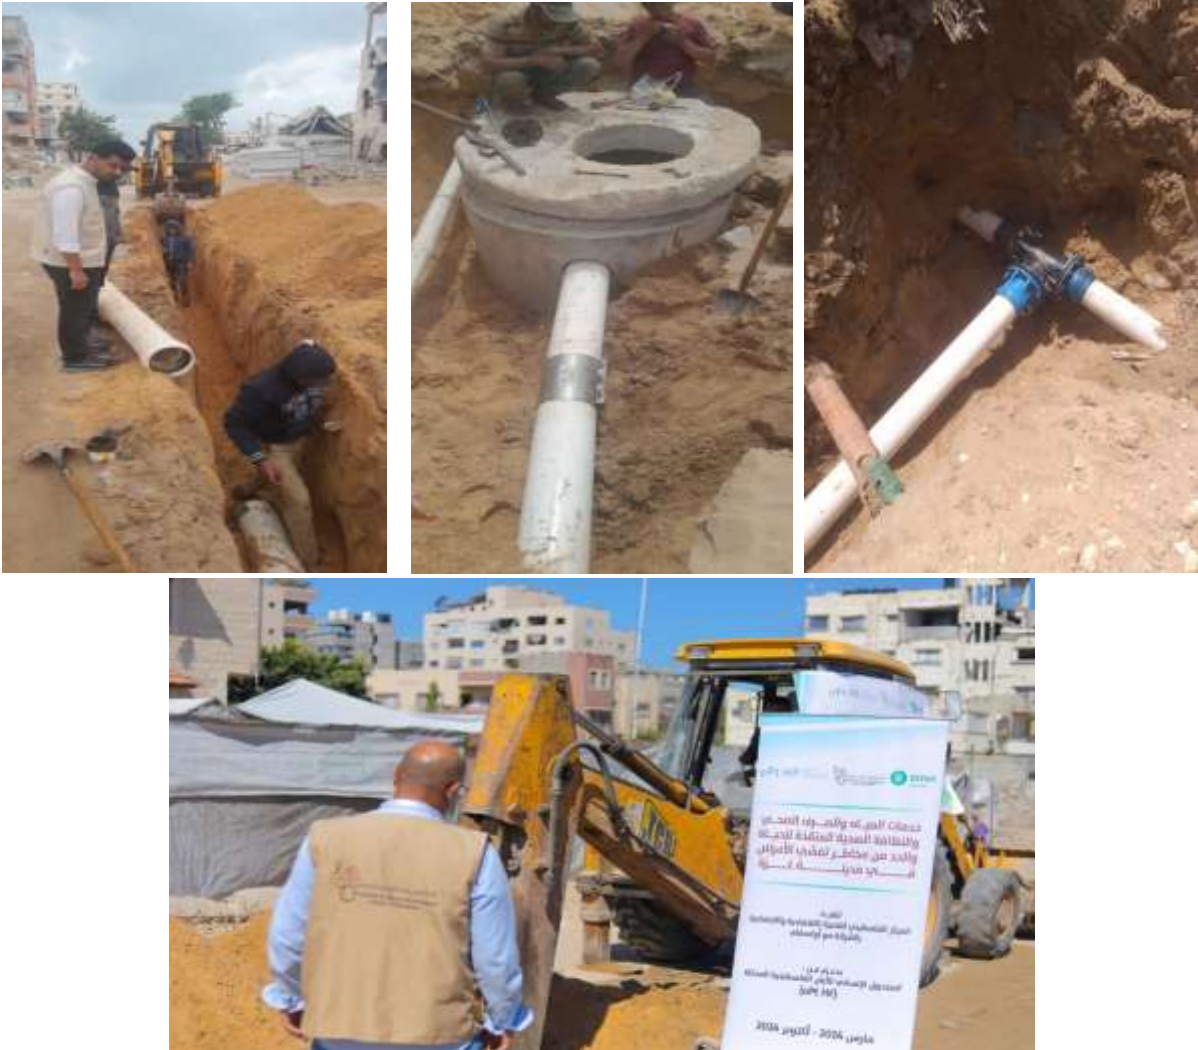
The CMWU through Oxfam and ESDC support is currently working on maintenance part of damaged water and wastewater networks in Tal Al Hawa area west of Gaza city. This project aims to improve the water services in this vital area and provide safe and reliable water access for more than 20,000 residents

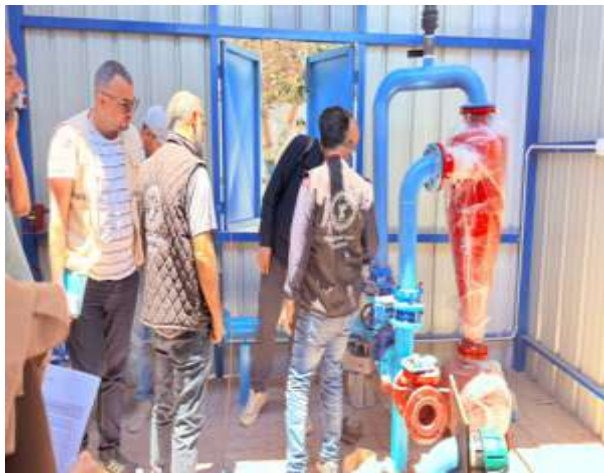
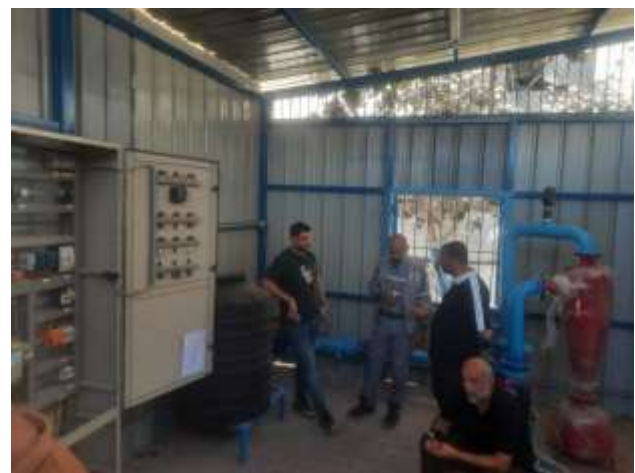
With support from PARC and CARE, CMWU is currently carrying out rehabilitation and maintenance works at Shabab and Reyada water well in Gaza City. The works include the maintenance of well pump, manifold, and electrical control panels, in addition to the construction of well rooms using steel-sheet structures.

This well serves thousands of residents in western Gaza City, providing a reliable source of safe water and contributing to the continuity of essential water supply services for the surrounding communities.

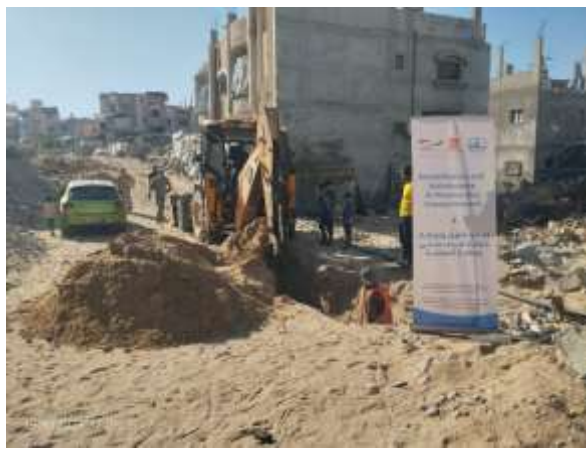
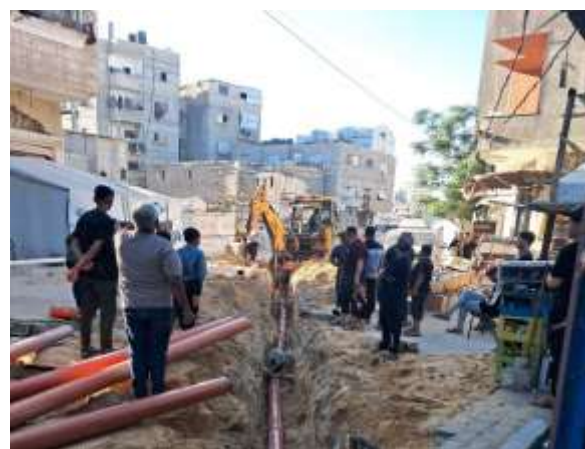
With support from NRC, CMWU is carrying out maintenance works on damaged sewage networks in three locations in Khan Younis, in order to reduce the risk of sewage flooding and mitigate associated environmental and public health hazards.

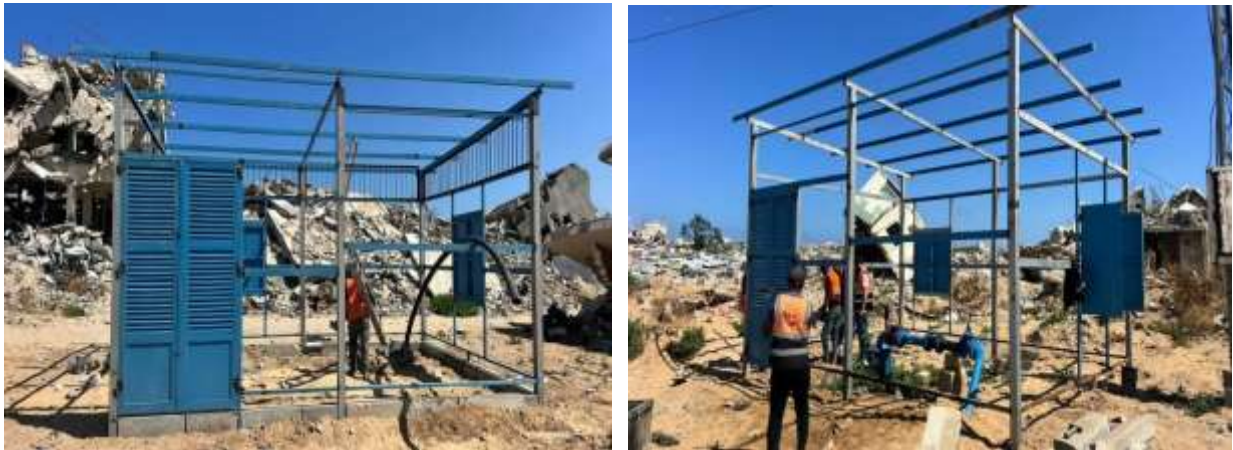
With support from NRC, The CMWU is carrying out maintenance works for two water wells in Beit lahia and one in Gaza city. the works includes maintenance the wells pumps, manifolds, pipelines, electrical equipments, in addition to construction wells room from steel structurers. The project aims to improve and provide reliable water access for more than 30,000 inhabitants living under severe conditions

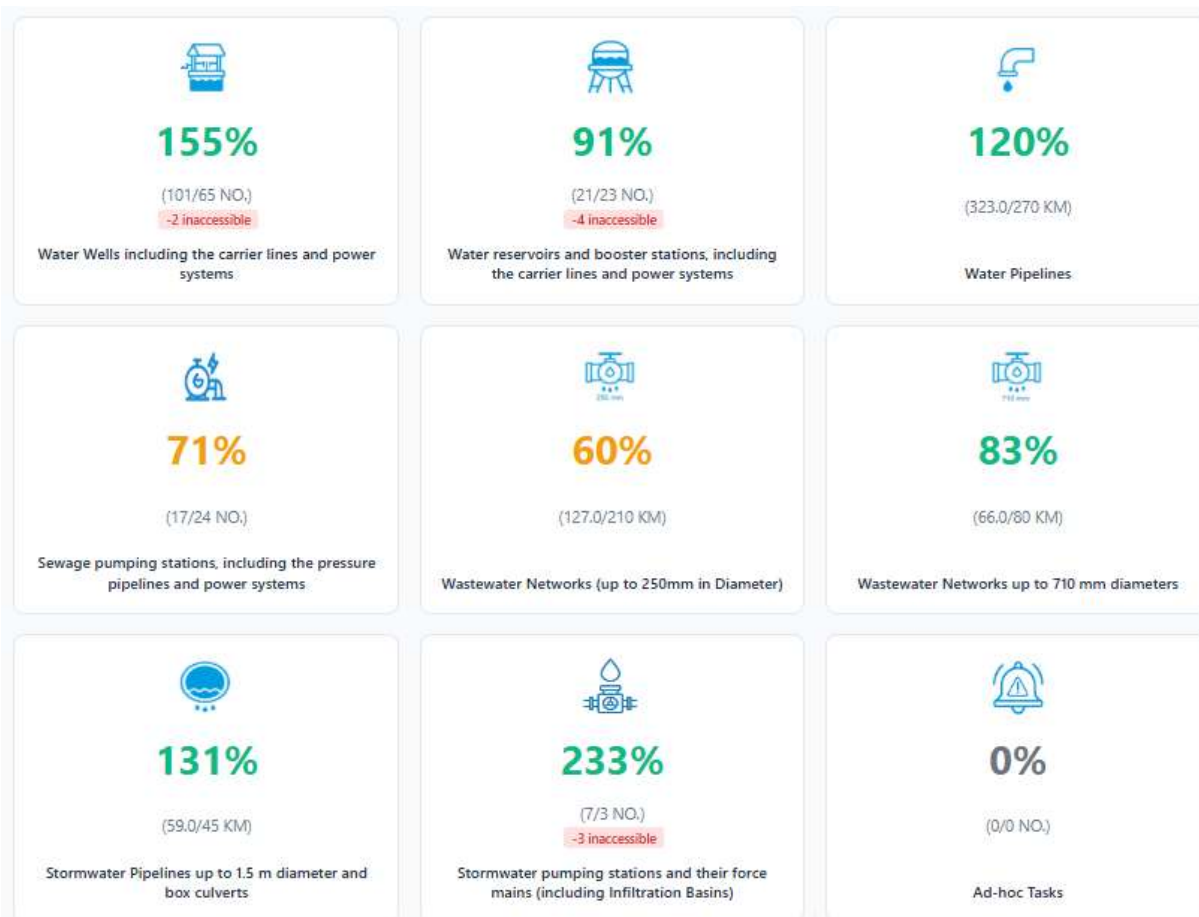
The field visits to Water and Wastewater networks that were completed by the Consultant's Team are shown in the dashboard as per the link below. The Consultant's Team was accompanied by Khan Younis municipality's engineers, See link below for further dashboard presentation <https://dash.rai-consult.com/Unicef-enhanced-dashboard>
